6.10.3 The Four Cases

6.10.4 Characterization of the Fires

6.12.6 Characterization of the Thermal Profiles

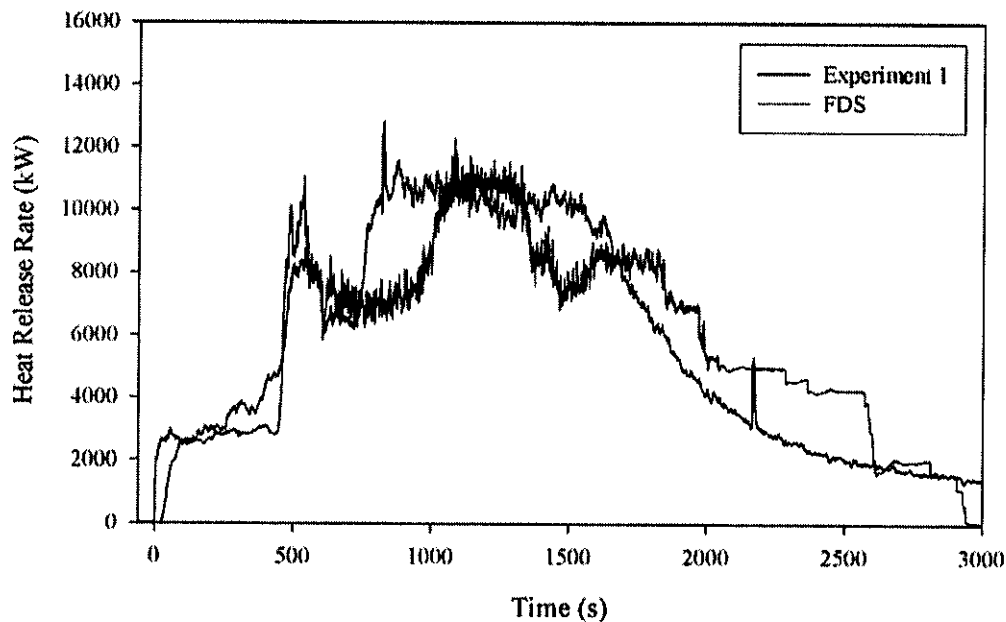
Figure 6–35. Measured and predicted heat release rate from the burning of three office workstations.

combustible mass of the rubblized workstations was consumed. The near-ceiling temperatures varied between 800 °C and 1,100 °C. Nonetheless, FDS successfully replicated:

- The general shape and magnitude of the time-dependent heat release rate.
- The time at which one half of the combustion energy was released to within 3 min.
- The value of the heat release rate at this time to within 9 percent.
- The duration of the fires to within 6 min.
- The peak near-ceiling temperature rise to within 10 percent.

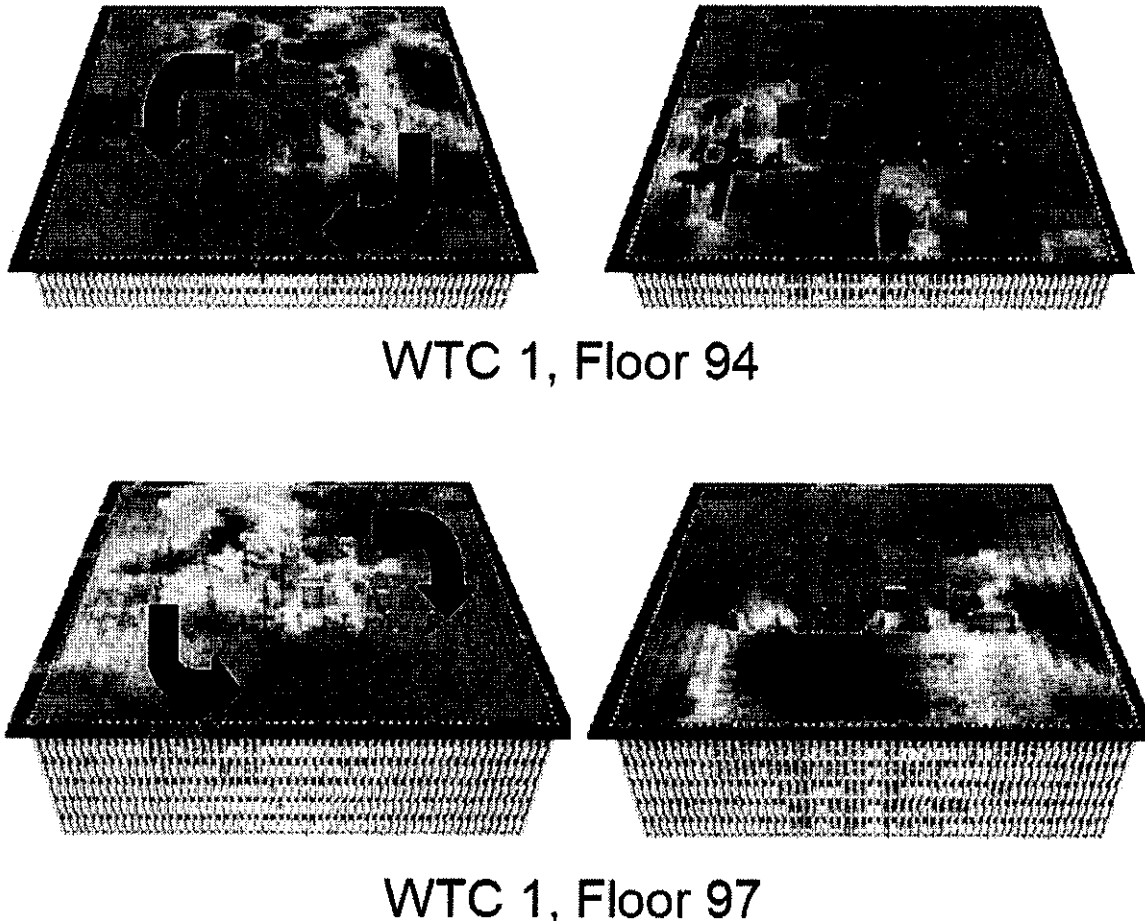
Much of the fire activity was initially in the vicinity of the impact area in the north part of the building. As a result of the orientation of the impacting aircraft and its fuel tanks, the early fires on the 92nd through 94th floors tended toward the east side of the north face, while the early fires on the 97th through 99th floors tended toward the west side of the north face. The fires on all the floors spread along the east and west sides and were concentrated in the south part of the building at the time of collapse, as depicted in Figure 6–37.

Figure 6–37. Direction of simulated fire movement on floors 94 and 97 of WTC 1.

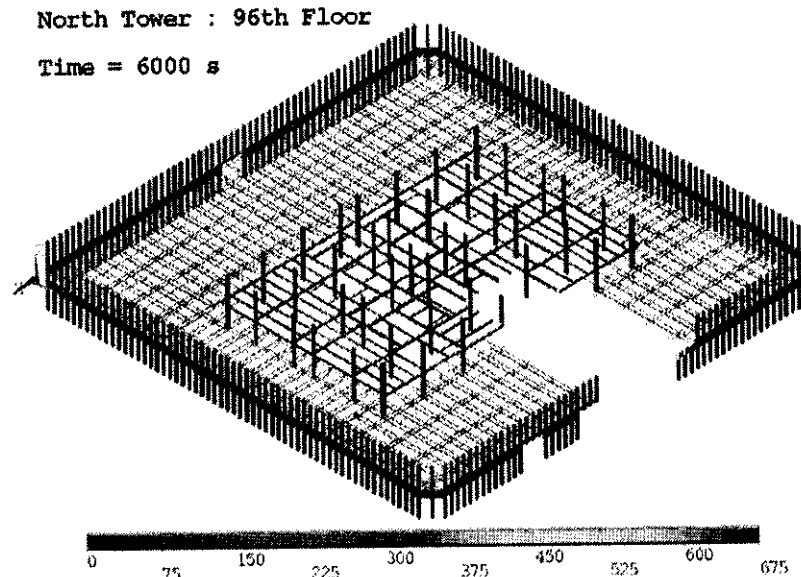
For ease of visualization, two graphic representations were developed. Figure 6-46 shows an example of the temperature map for the 96th floor of WTC 1. Severed columns and broken floor segments are not shown. Figure 6-47 shows a similar map for the 81st floor of WTC 2.

Figure 6-46. Temperatures (°C) on the columns and trusses of the 96th floor of WTC 1 at 6,000 s after aircraft impact, Case B.

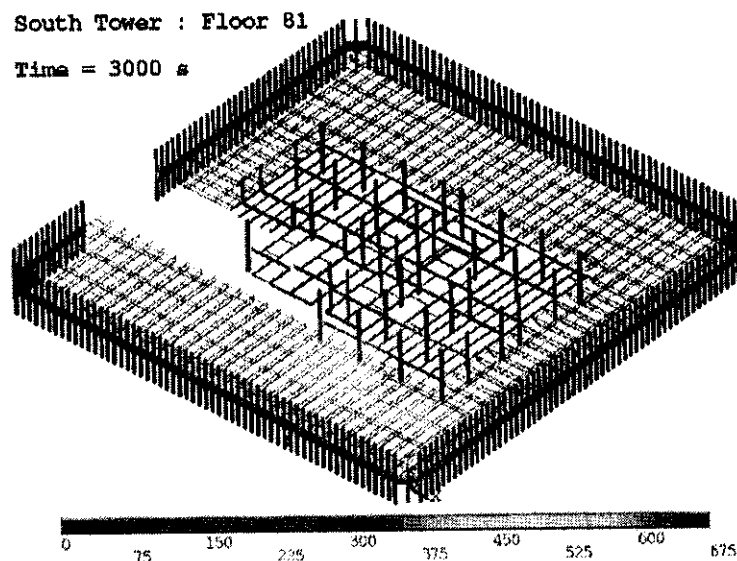
Figure 6-47. Temperatures (°C) on the columns and trusses of the 81st floor of WTC 2 at 3,000 s after aircraft impact, Case D.

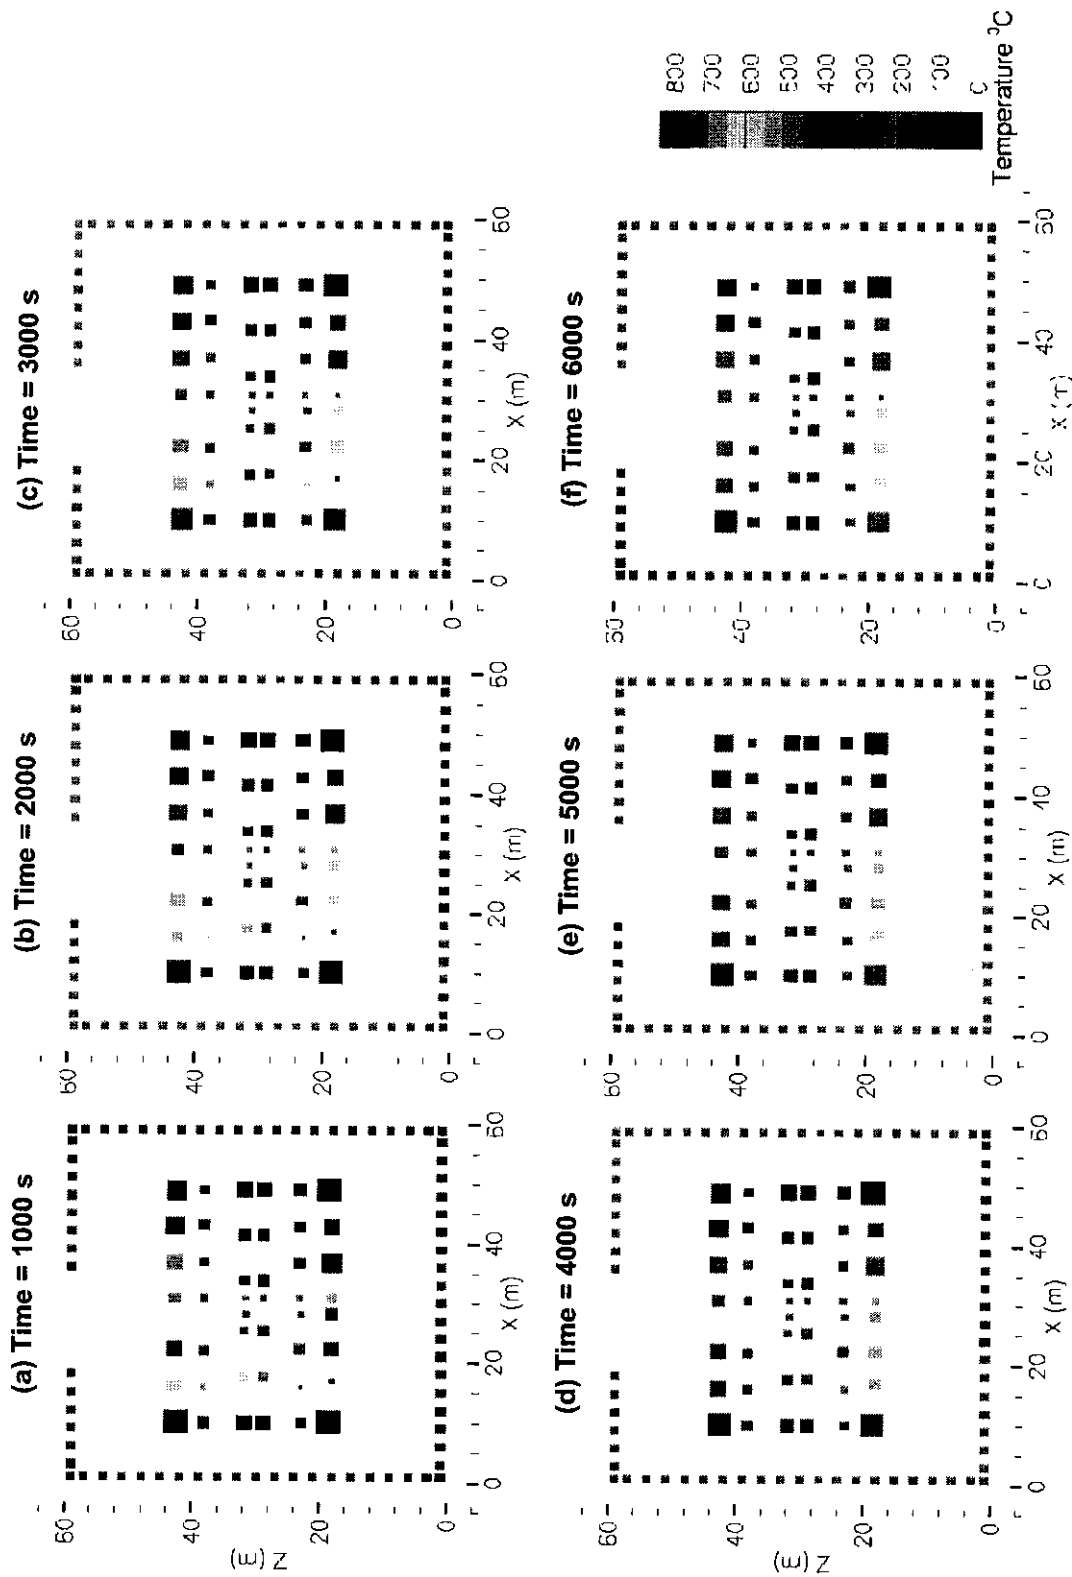
A third visualization tool was animation of the evolving temperatures of the columns. Frames from an example, again of the 96th floor of WTC 1, Case A, are shown in Figure 6-48. The size of the square representing a column represents its yield strength. Columns may have been heated when the fire was nearby and then cooled after the local combustibles were consumed.

Figure 6-48. Frames from animation of the thermal response of columns on the 96th floor of WTC 1, Case A.

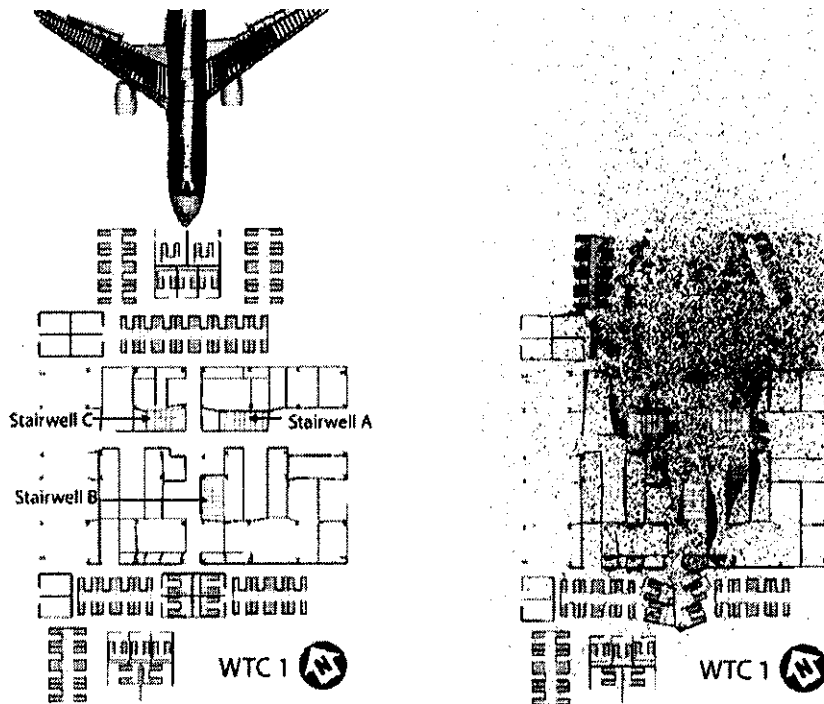
Figure 7-1. Simulated impact damage to 95th floor of WTC 1, including stairwells, 0.7 s after impact.

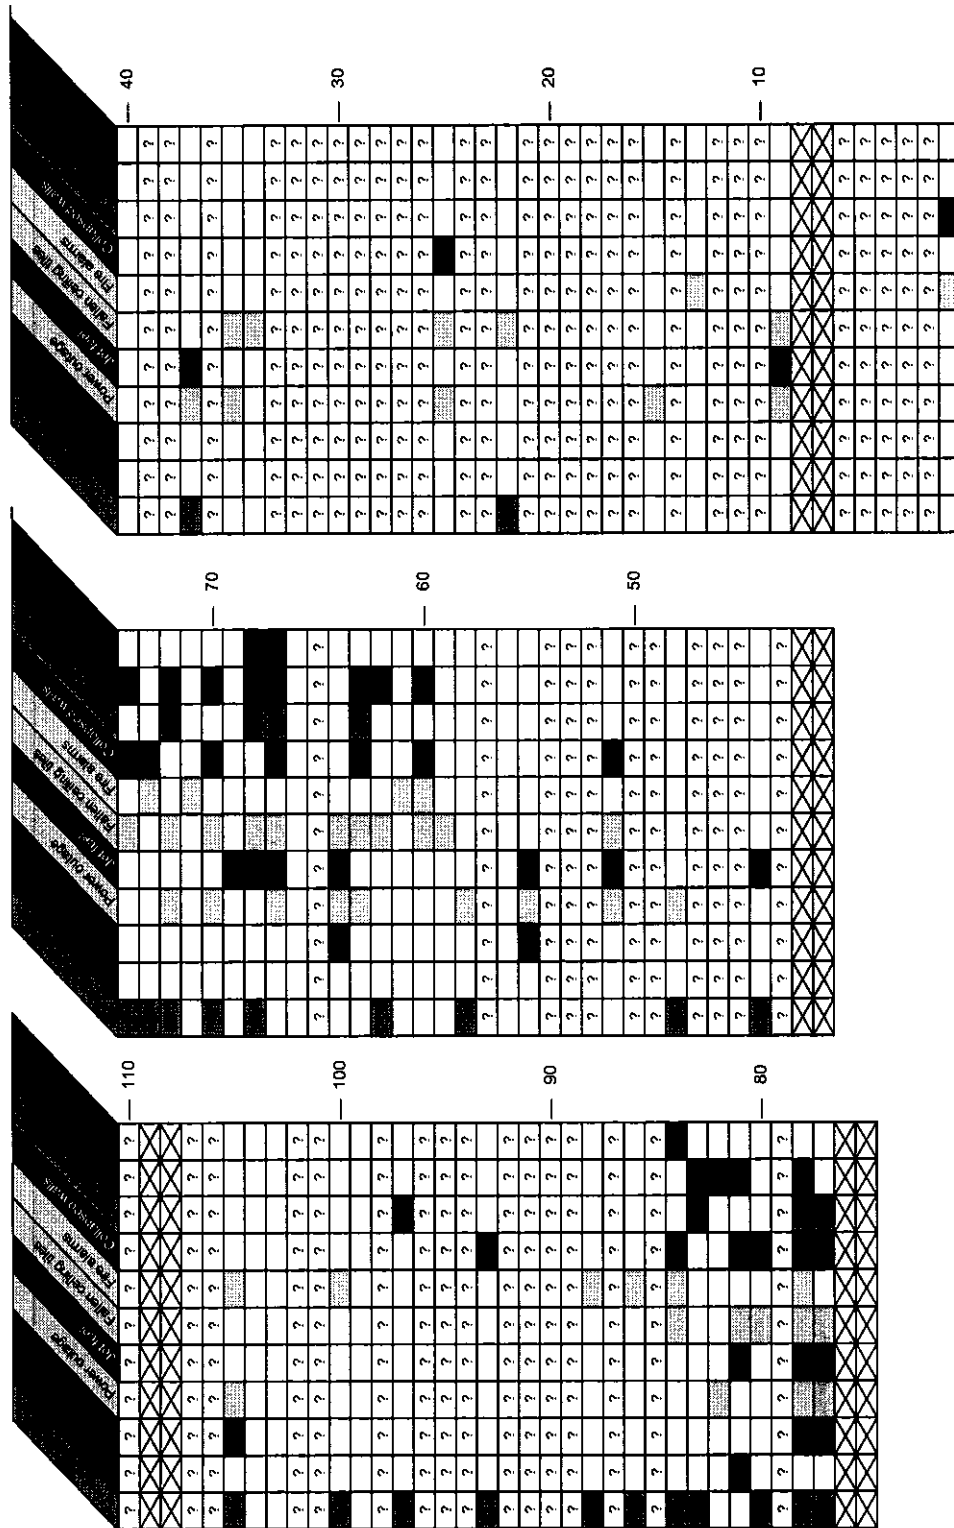
Figure 7-4. Observations of building damage from tenant spaces in WTC 2.
